**OPWDD MONROE WESTFALL
MOON STREET WING
RENOVATION BRIDGING
DOCUMENTS**

JULY 31, 2023

The project involves the rehabilitation of two (2) north-western wings of Moon Street; with (2) sub-units each; A & B into thirteen (13) bedroom hostel exterior courtyard and security improvements, roof replacement, window replacements, reconfiguration of interior spaces, FFE upgrades, and improvements to the HVAC, plumbing, electrical, fire alarm and security systems.

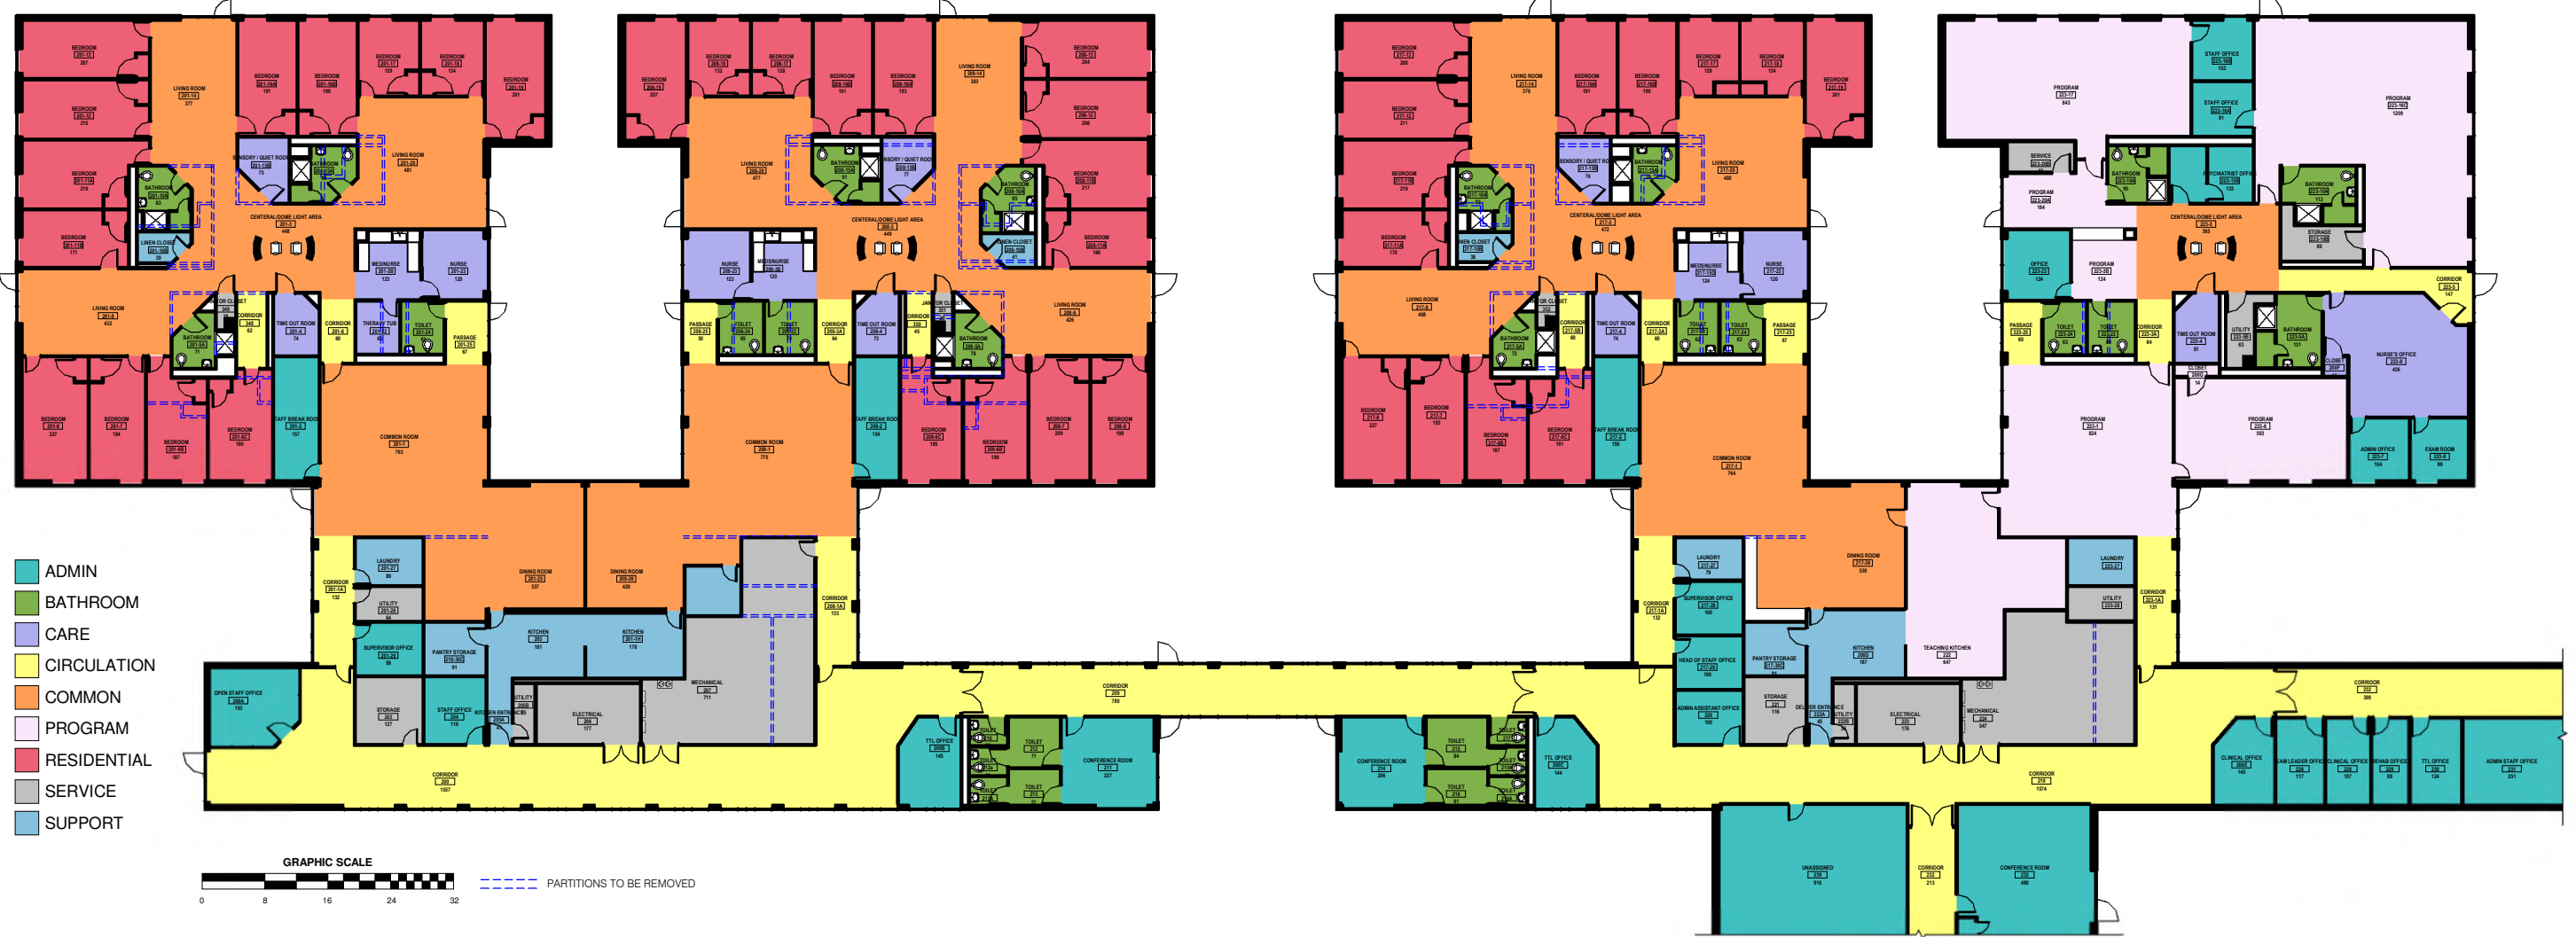
GRAPHIC SCALE
 0 8 16 24 32
 PARTITIONS TO BE REMOVED

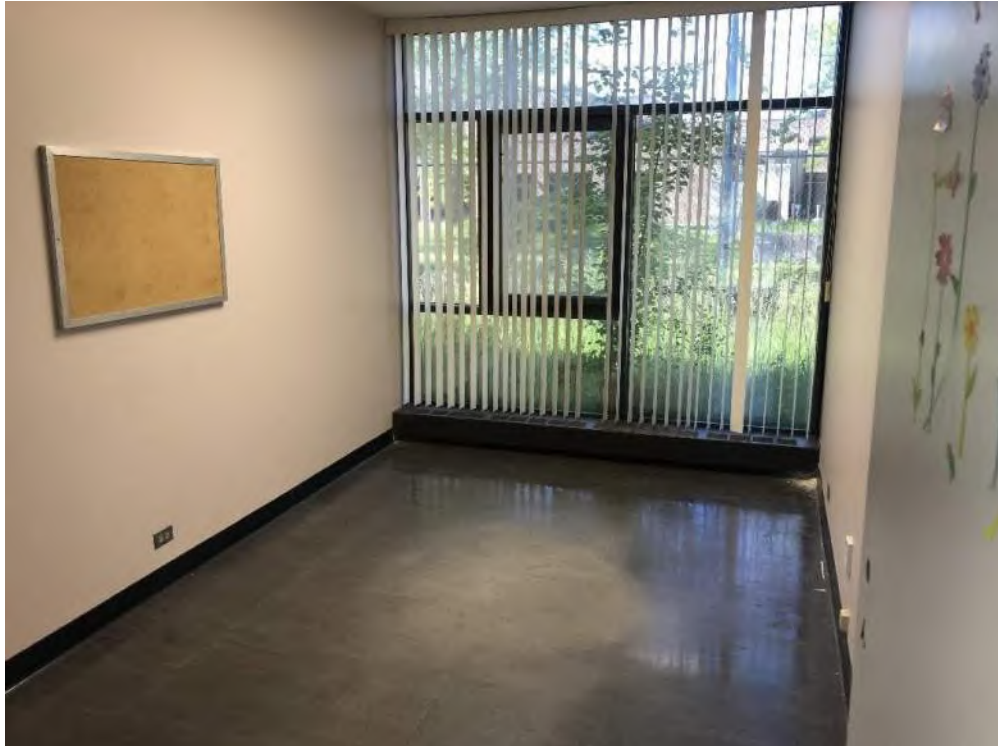
Photo 1: View of the asbestos-containing black 12"x12" floor tile. Associated black mastic is also asbestos-containing.

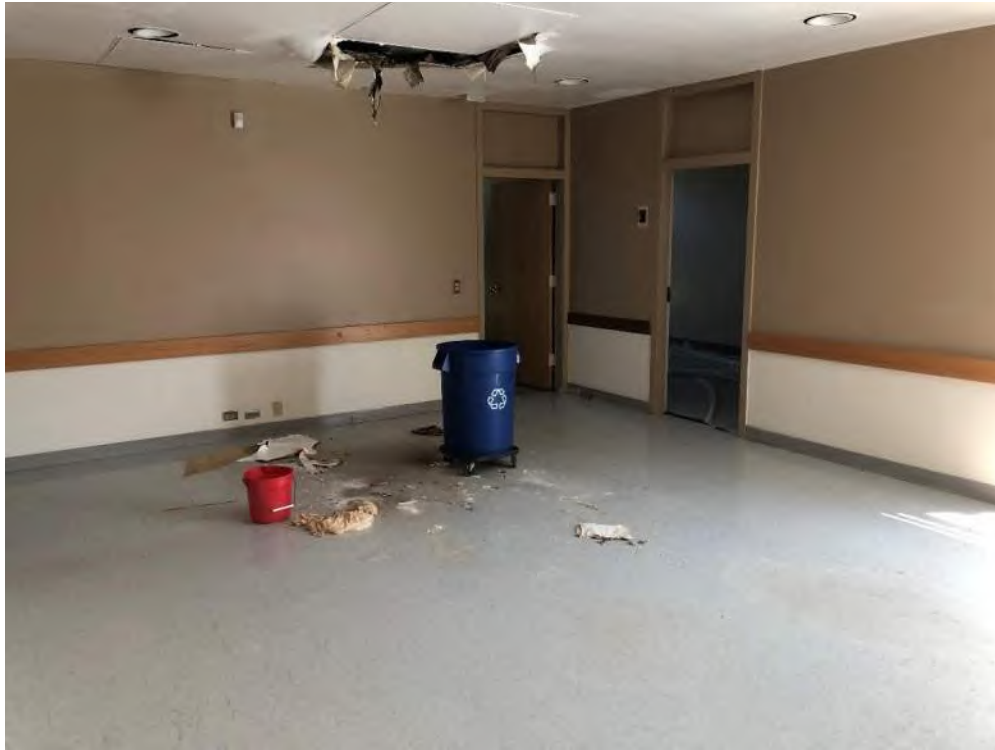
Photo 3: View of asbestos-containing drywall ceiling joint compound in room 217-20, where the ceiling has fallen down and created a disturbance.

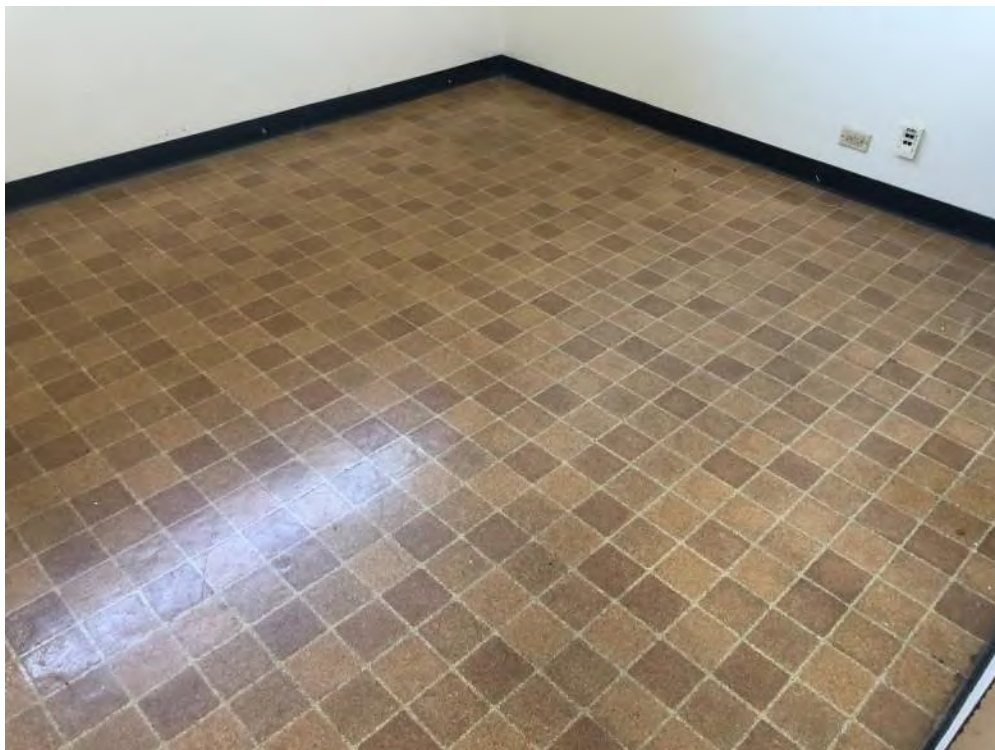
Photo 4: View of the asbestos-containing brick pattern floor covering.

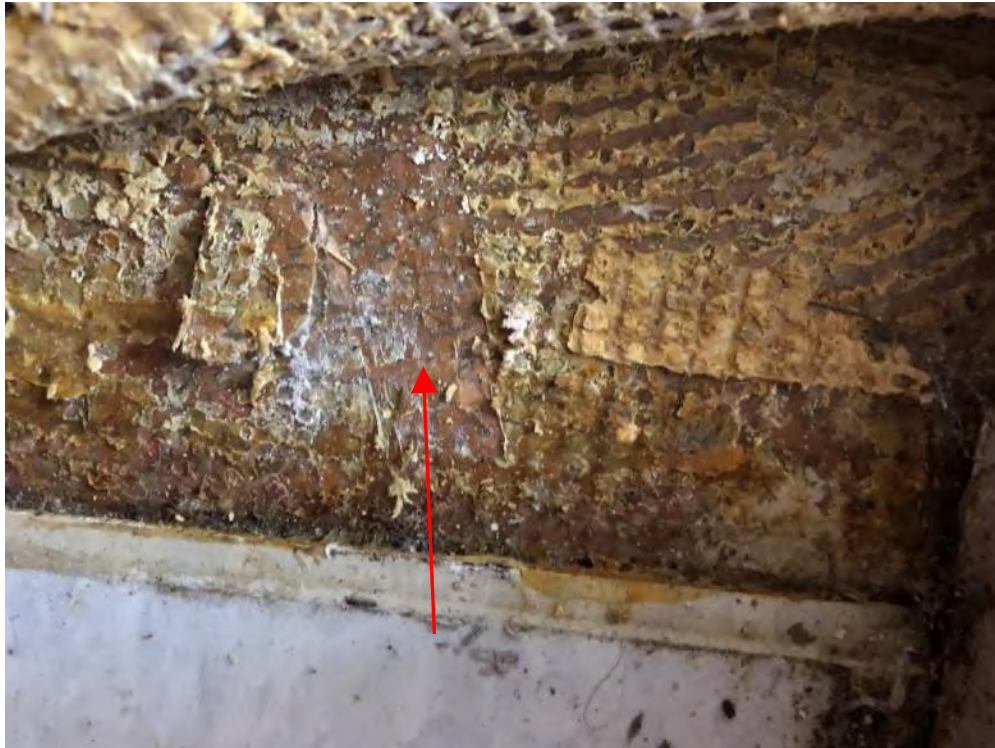
Photo 5: View of the asbestos-containing brown floor covering.

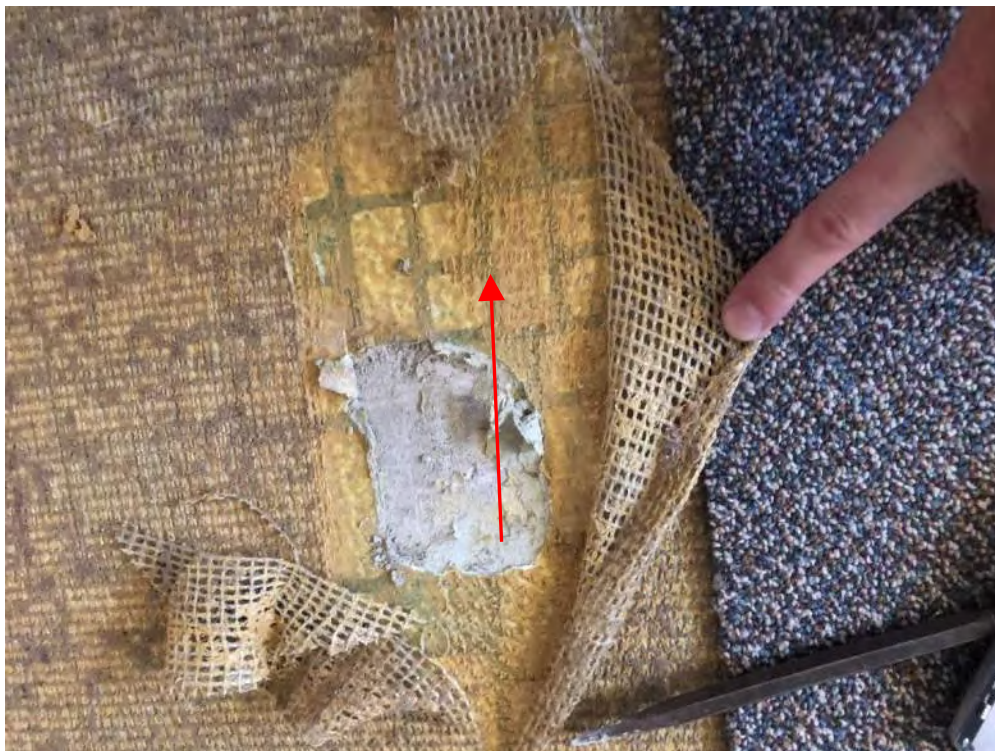
Photo 6: View of the asbestos-containing blue/tan floor covering.

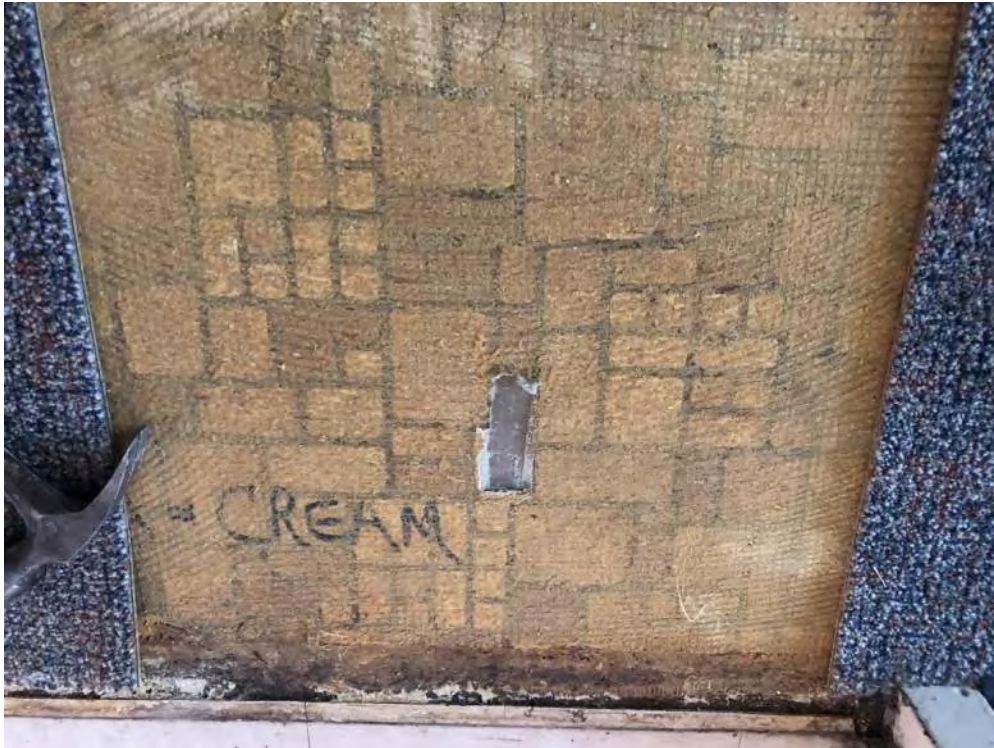
Photo 7: View of the asbestos-containing cream floor covering.

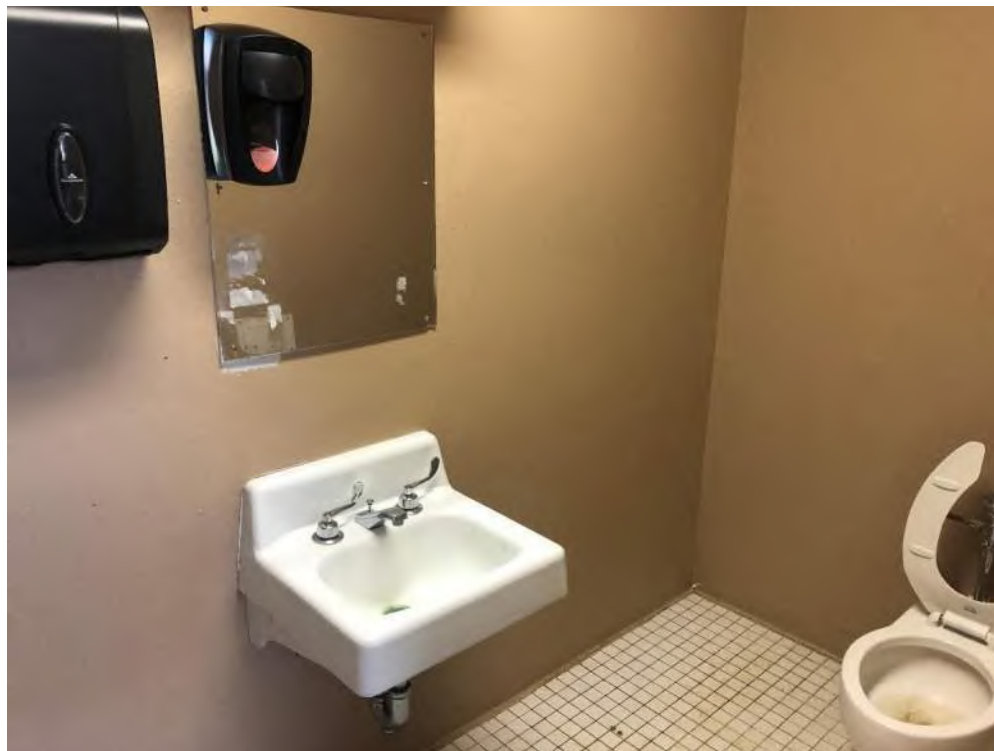
Photo 8: View of a typical white ceramic sink that has a lead coating.

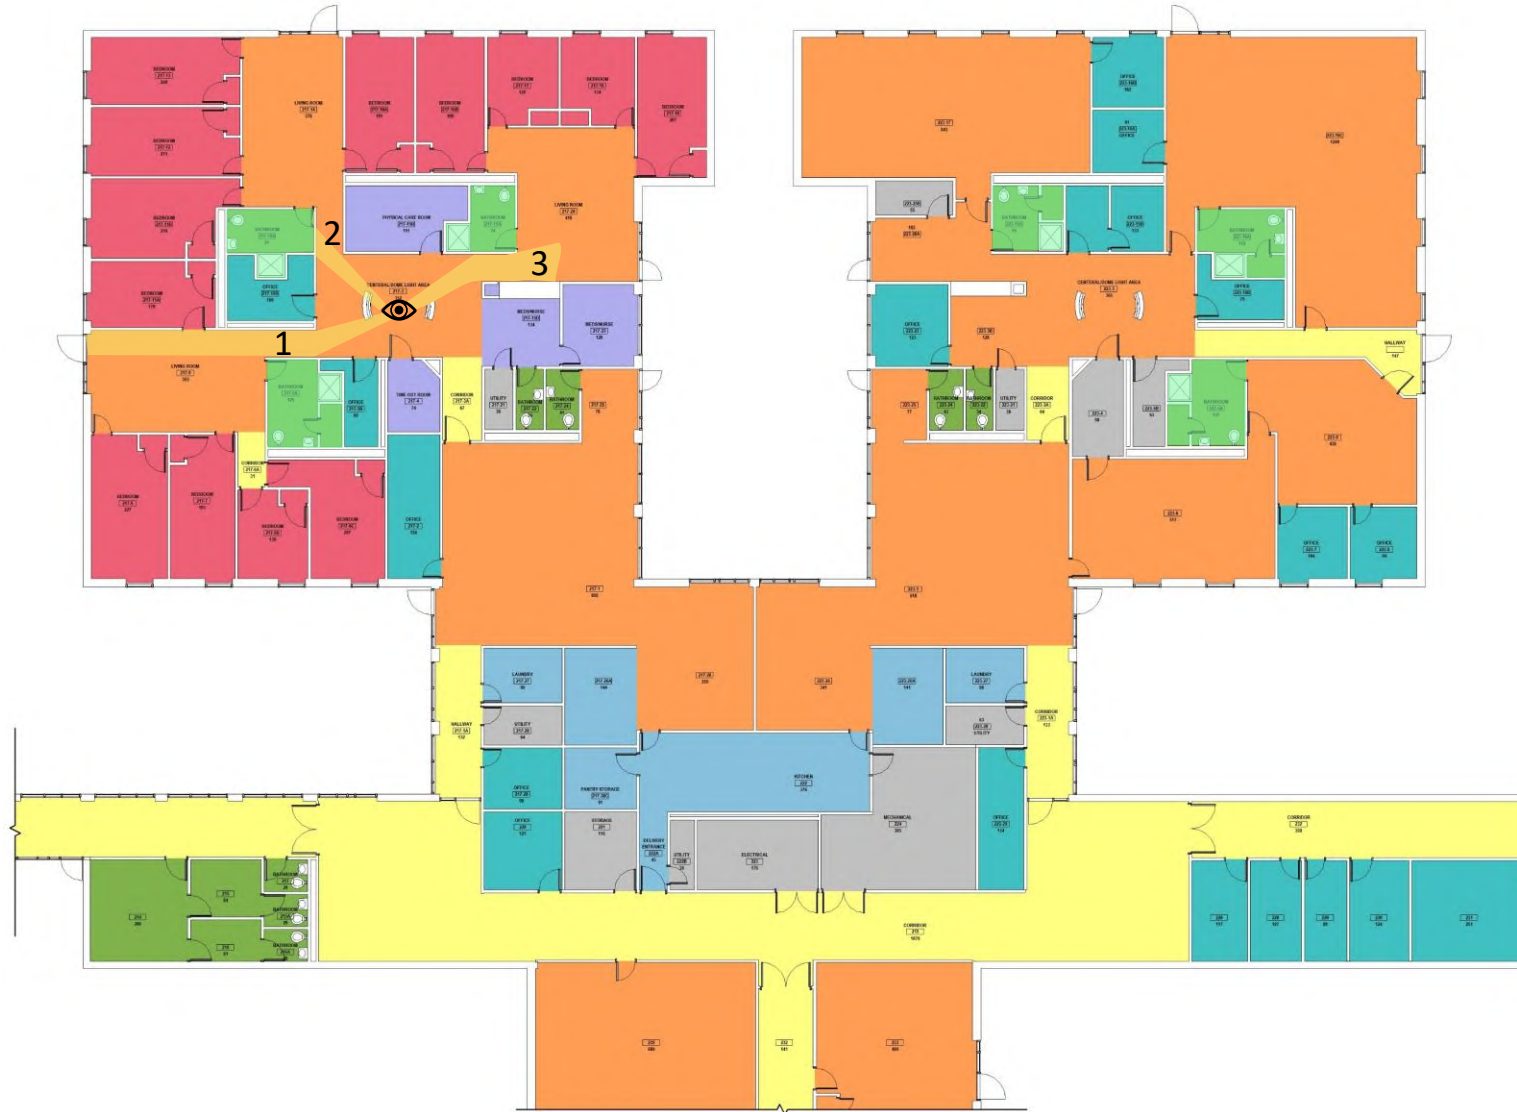
Existing Sight Lines

- Plan Legend**
- Sight Line
 - Non-Compliant Bathroom
